September 1984
Final Report

DOT HS 806 666

AIRBAG DEMONSTRATION PROGRAM
PHASE III

15. Supplementary Notes			
16. Abstract <u>Abstract</u> Driving and Barrier Tests were performed to determine acceleration levels required to cause an accidental deployment of a Romeo-Kojyo airbag system and a Breed Corporation Mechanical Airbag System sensor.

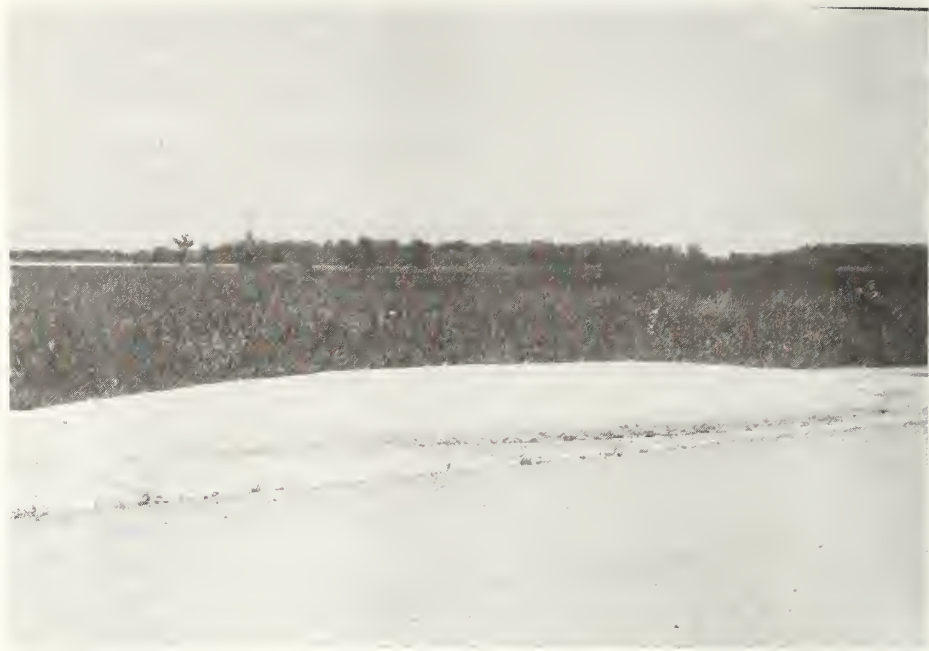
Single Bump, side view

Single Bump (Figs. 1 & 2) An oblong shaped concrete block, six inches tall with a ramp at both ends. The entrance ramp starts at ground level and is 48 inches wide. It rises to six inches over a distance of seven feet and widens out to 120 inches at the same point. The exit ramp tapers from 120 inches to 102 inches in width and comes back to ground level over a distance of 66 inches. The bump is flat on top over a length and width of ten feet.

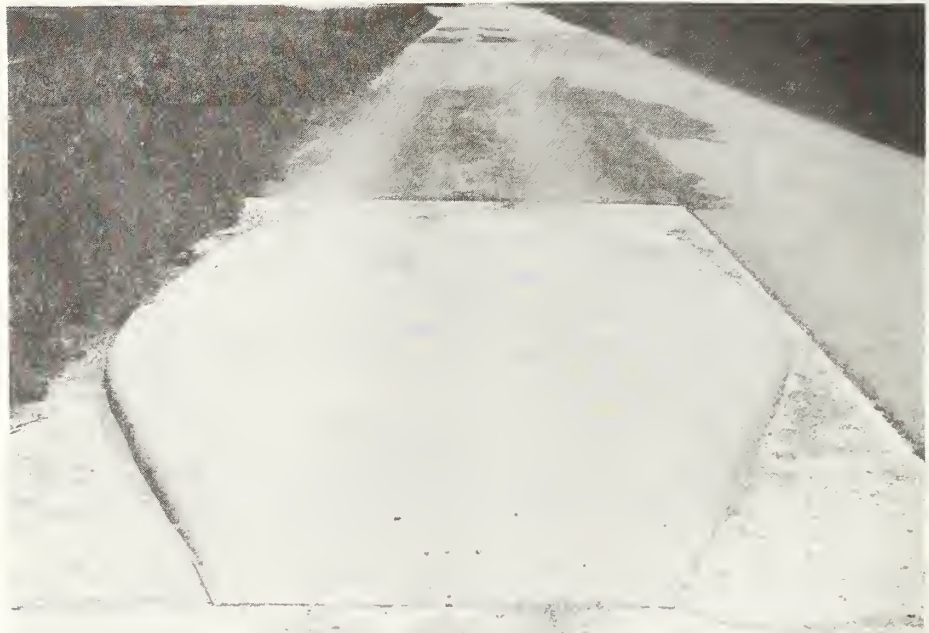
Single Bump,
Entering View

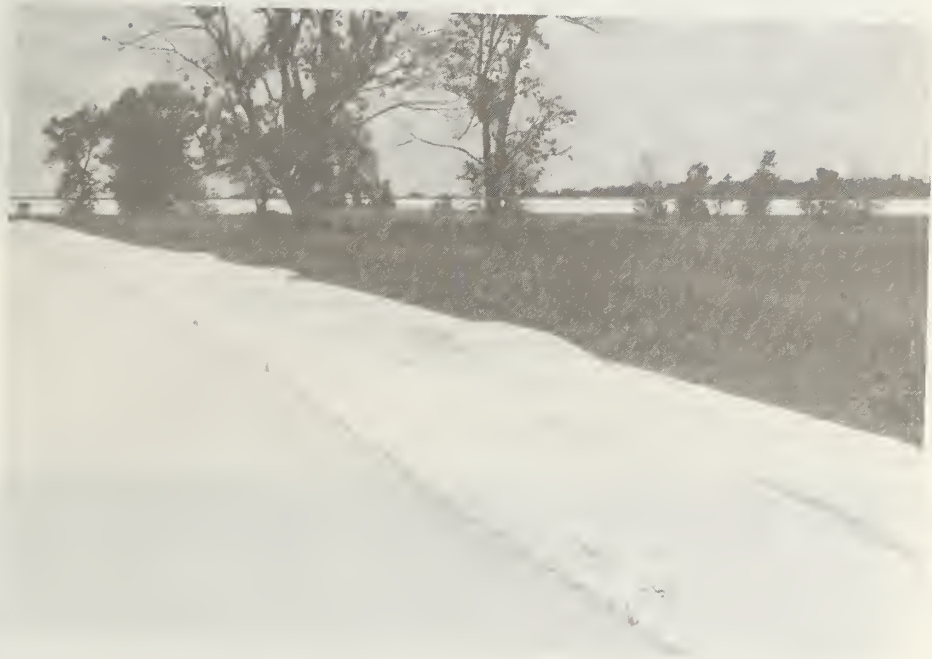
Stagger Bumps

Stagger Bumps (Fig. 3) A series of smaller ramped bumps, each being sixteen feet long start to finish, rising to a height of six inches in the center and having a driving surface 36 inches wide. They are located so that the first, third, and fifth bumps are encountered by the left tires of a vehicle and the second, fourth, and sixth are encountered by the right tires. The track center between left and right side bumps is six feet. The spacing from center to center of the bumps is as follows:

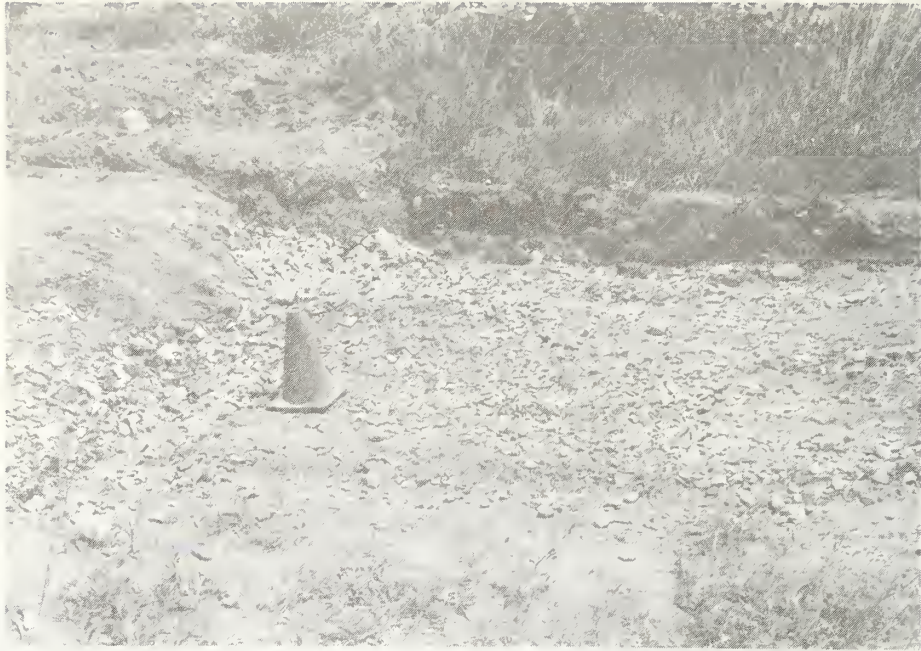
Ditch, Side View

Ditch (Figs. 4 & 5) A man-made pit ten feet wide, twelve feet long, and twelve inches deep. The entrance wall is very nearly vertical having a slightly rounded top edge. The exit side is tapered to create a ramp six feet long. The flat distance along the bottom of the pit from the entrance wall to the start of the exit ramp is four feet.

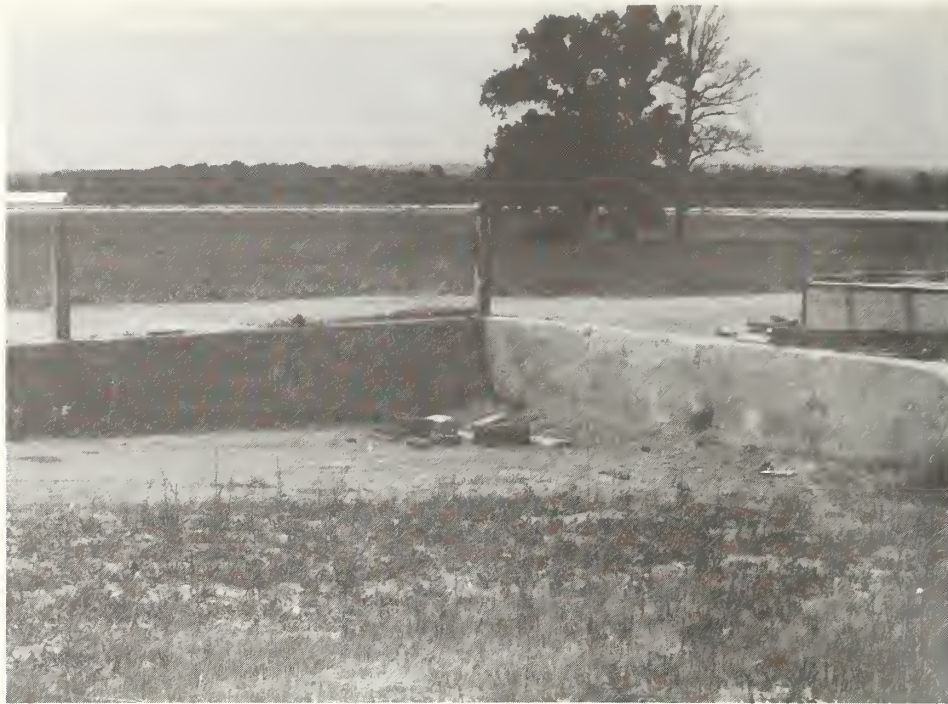
Loading Dock
Overall View

Dock (Figs. 8 & 9) Used as a fixed rigid barrier, this was actually a loading dock which is built such that its upper surface is at ground level thereby creating a ramp to the lower level down which the vehicle could roll without a driver. The striking surface is concrete backed by earth.

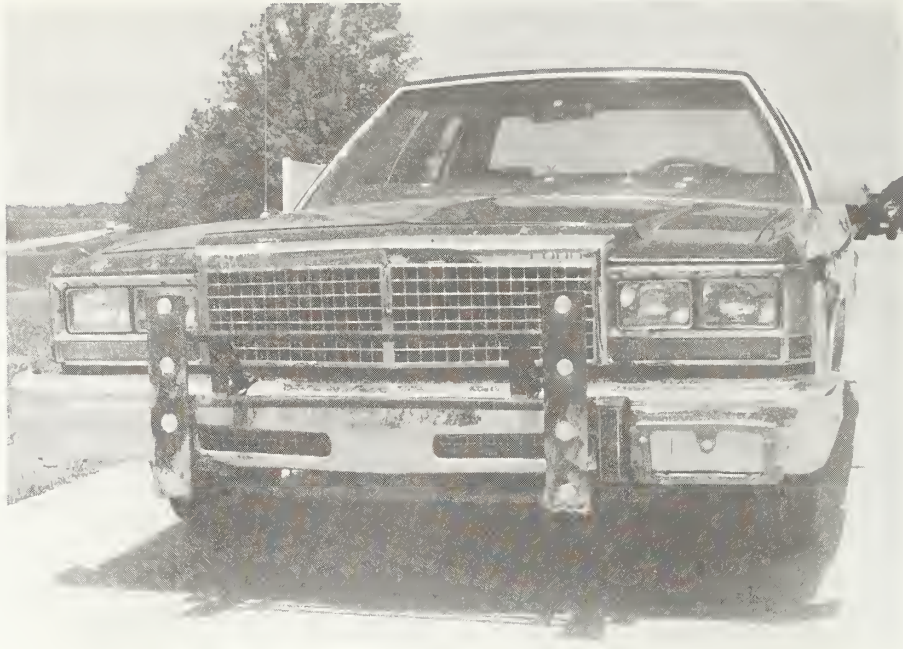
Ford LTD
Pre Loading Dock Testing

During the course of the loading dock testing, the front end of both vehicles became progressively more damaged. Both vehicles' front bumpers were hanging down at angles approaching 45 degrees before testing was halted. For this reason, results from the loading dock tests should be used only as indicators of trends and not valid data. (Figs. 13 thru 18)

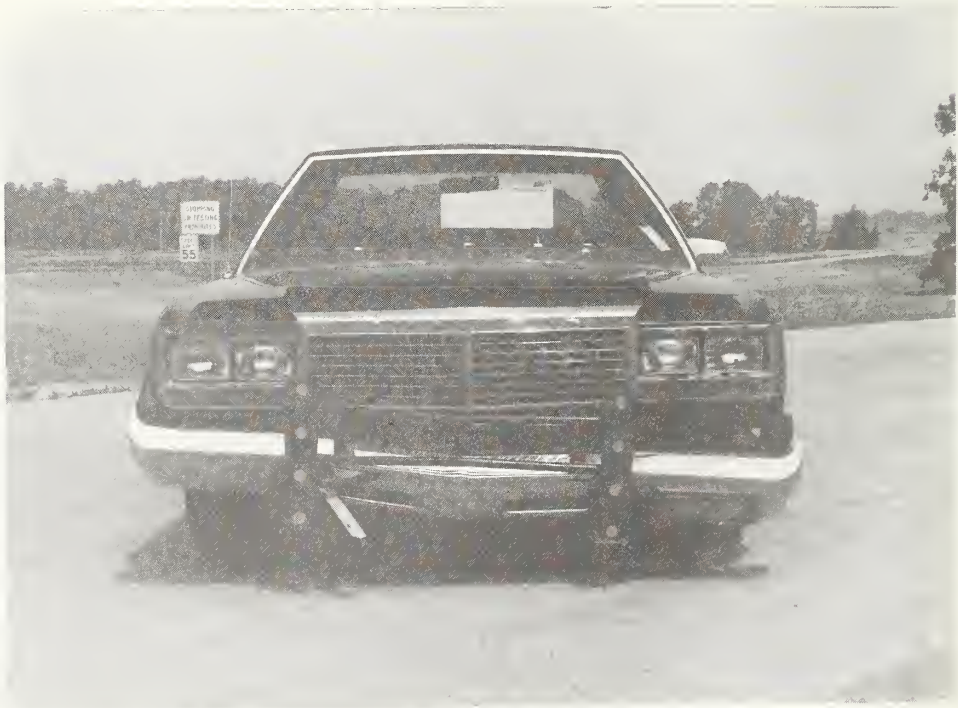
Ford LTD
Post Loading Dock Testing

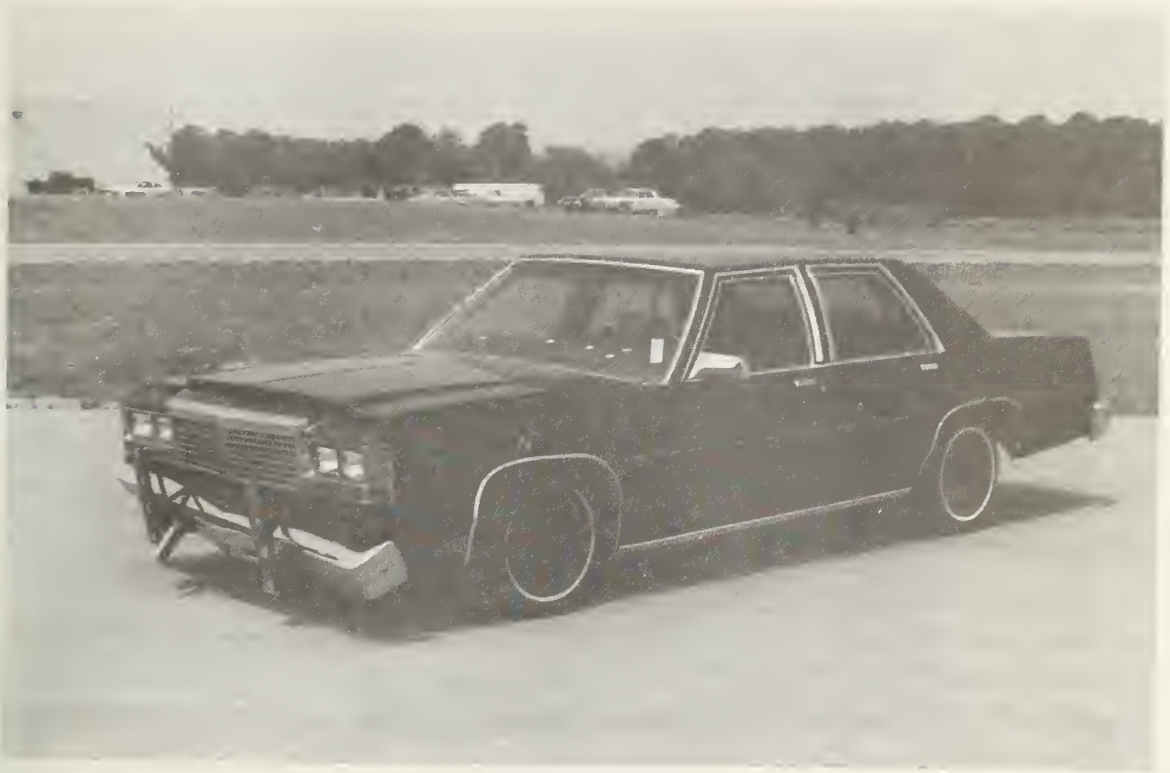
Ford LTD
Post Loading Dock Testing

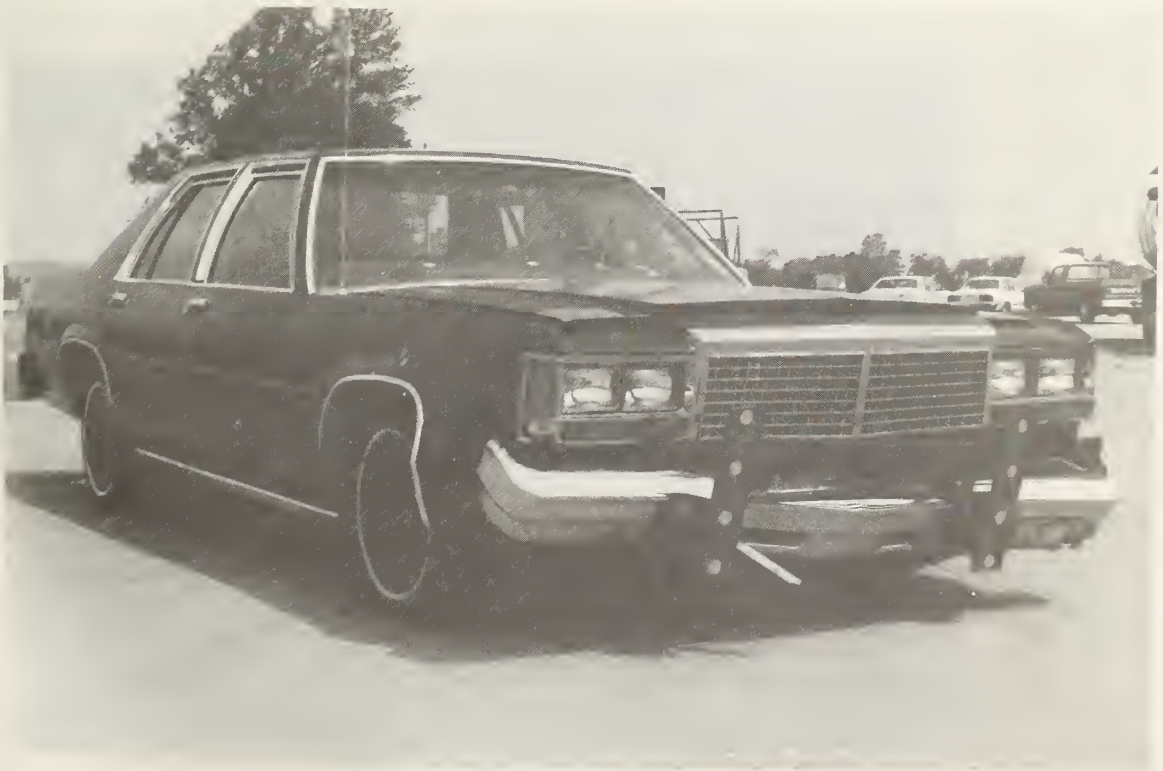
Ford LTD
Post Loading Dock Testing

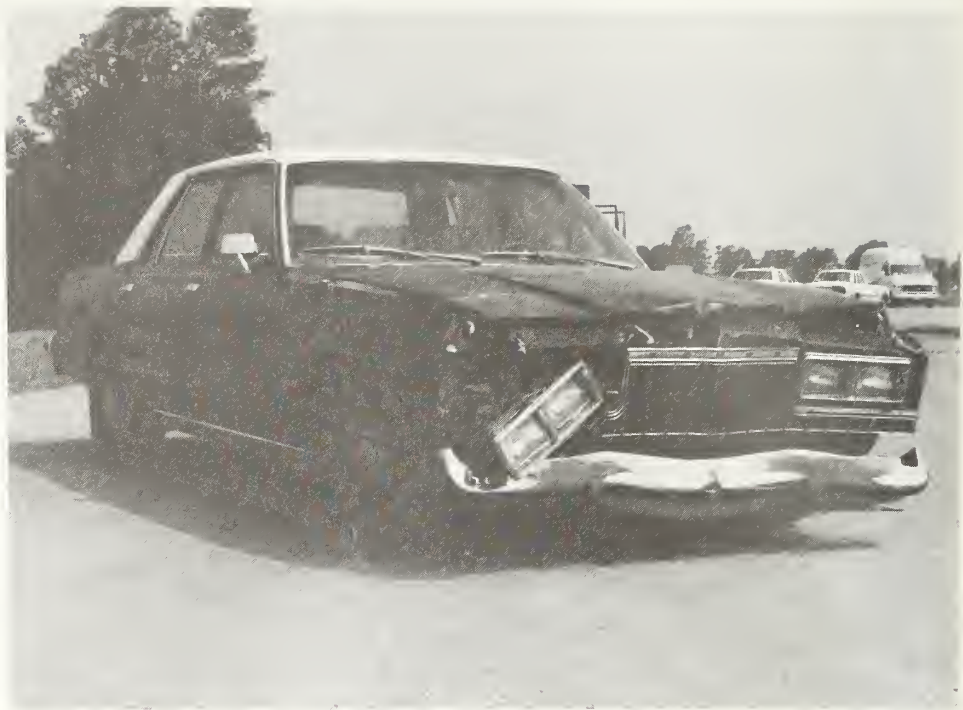
Dodge Diplomat
Post Loading Dock Testing

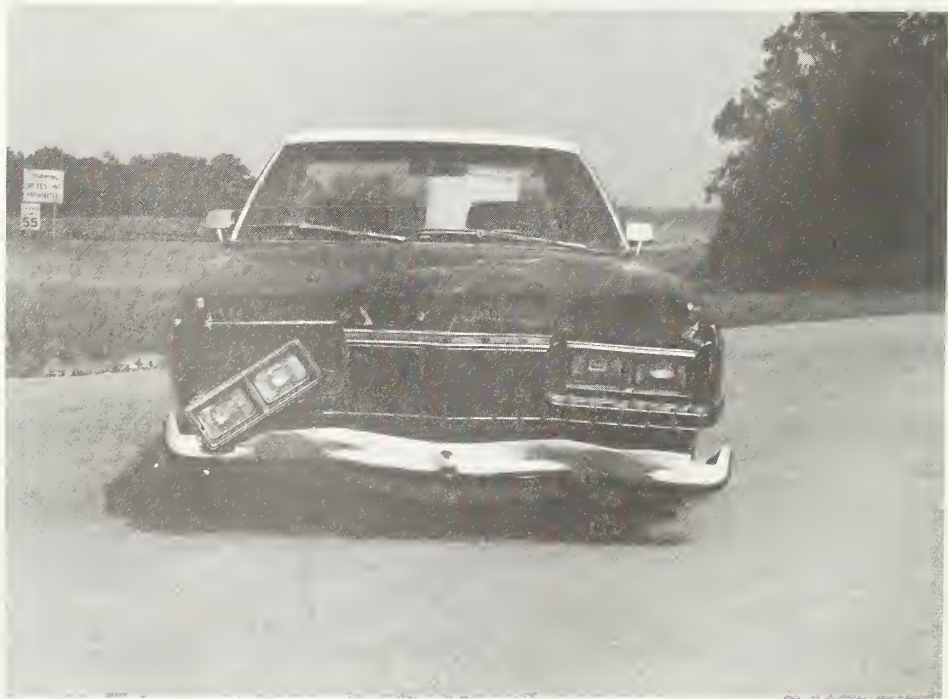
Dodge Diplomat
Post Loading Dock Testing

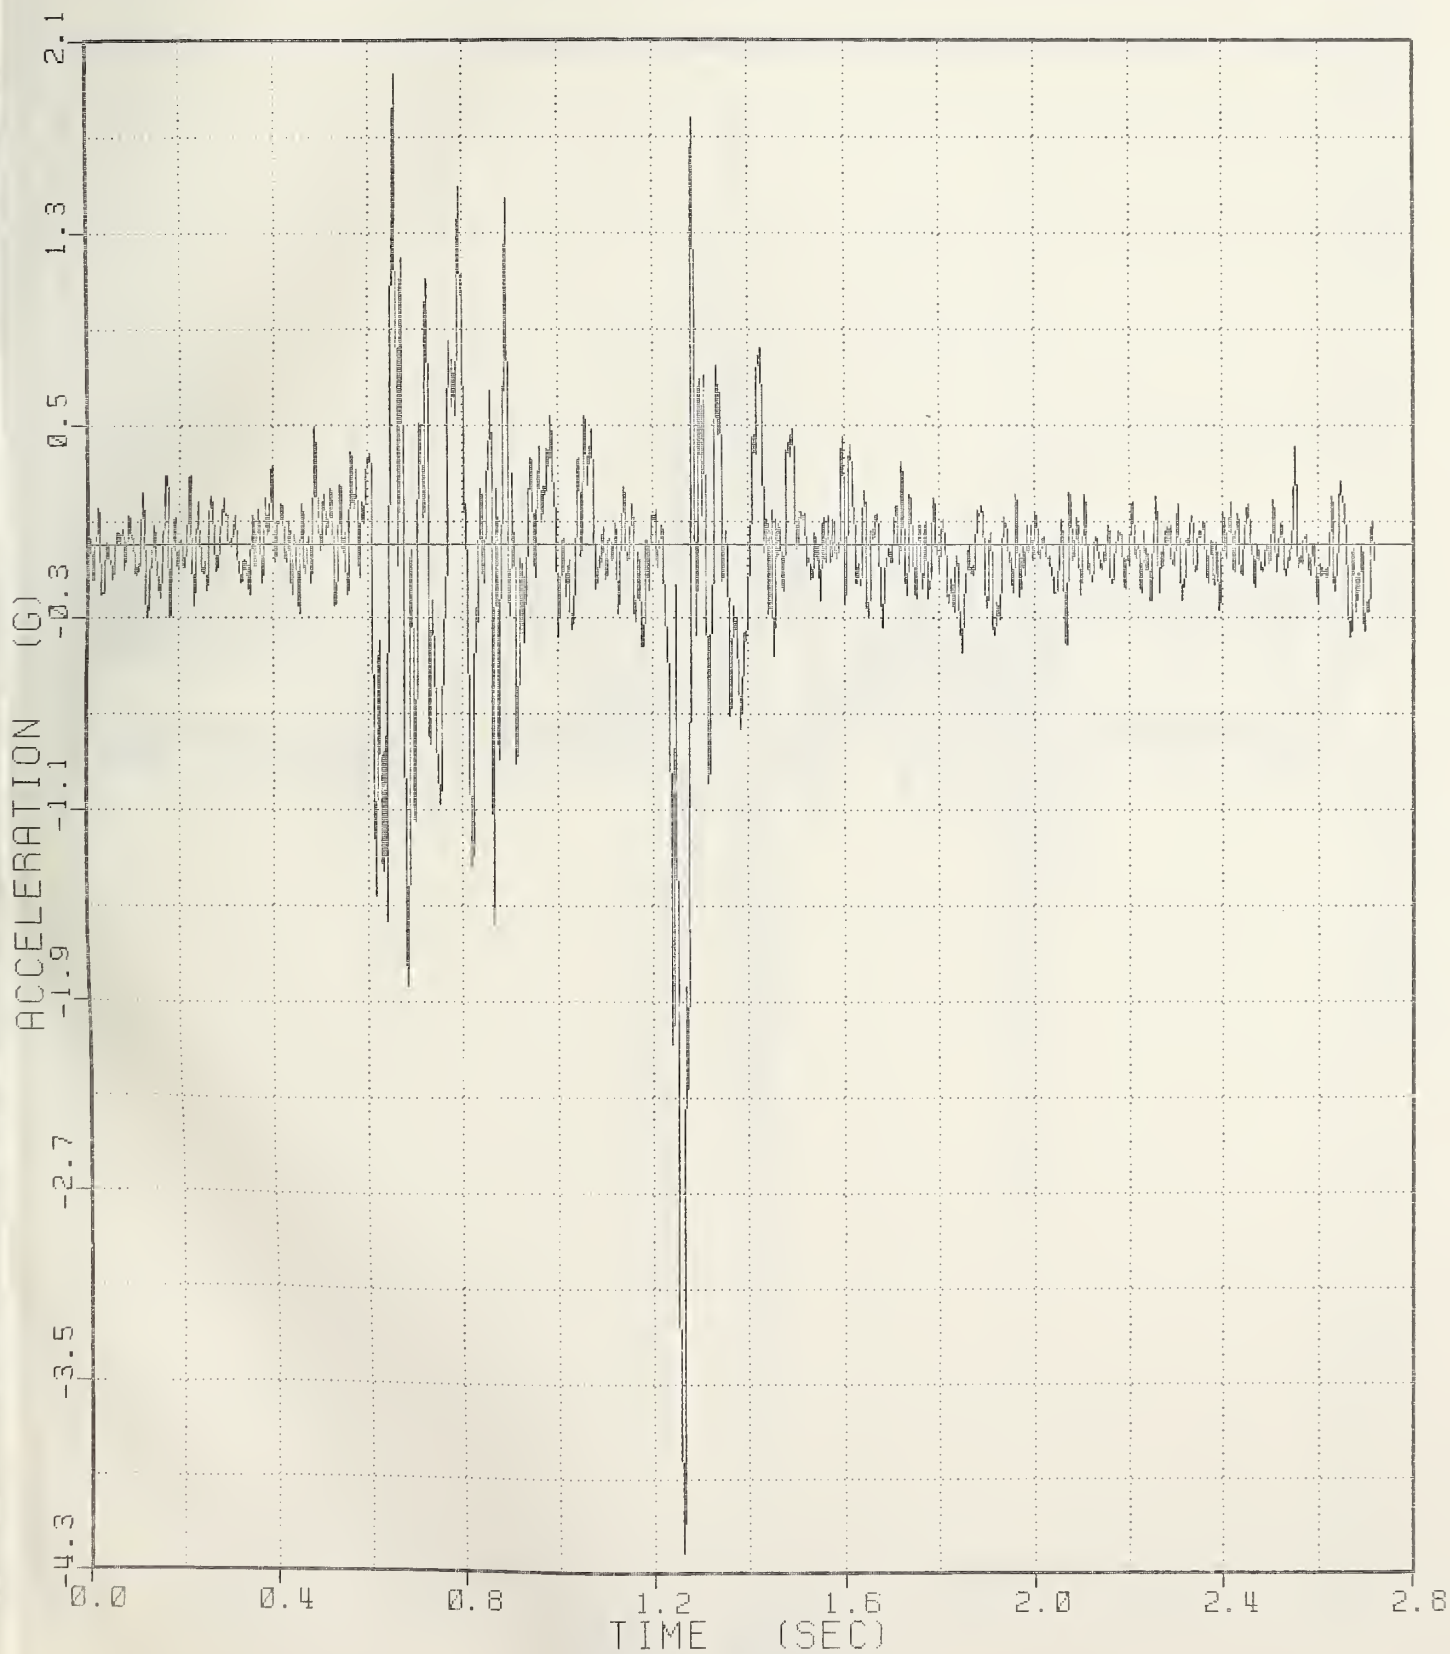
030 FFCXGR

FFCXGR - Acceleration in G's in the X axis at the front frame member on the right side. This is the location of the Right Front Romeo-Kojyo firing sensor.

030ZF RD503-2 TST030 84171083915 28-AUG-84 16:06:36
FFCXGR FILTER = BLPP 100/ 316/ -40 0.0 MPH
MIN, MAX VALUES = -4.21443 0 1.2608 1.96063 0 0.6544

Strip chart data is presented in appendix 3 for the most severe traverse of each driving surface for each car. Note that the most severe traverse is not always the fastest.
